# ROANOKE PARKS AND RECREATION PRESTON PARK RECREATION CENTER FEASIBILITY STUDY

AUGUST 4, 2017  
PROJECT NO. 16100

# Preston Recreation Center Feasibility Study

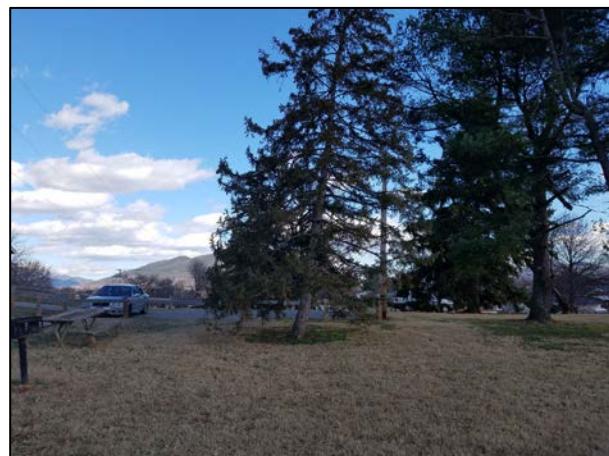
Landscaped Parking Lot

The parking lot provides (18) standard auto parking spaces and (1) 10'x25' delivery space. Six of the auto spaces are on asphalt and the remaining 12 are grass parking. A single Handicapped space is required by ADA and two are provided along Preston Avenue at the front door entry sidewalk. The building porch is currently used for parking although use of these spaces do not appear to be intended.

Replace the horizontal parking lot fence members within the next 2-5 years with more substantial 3"x6" lumber.

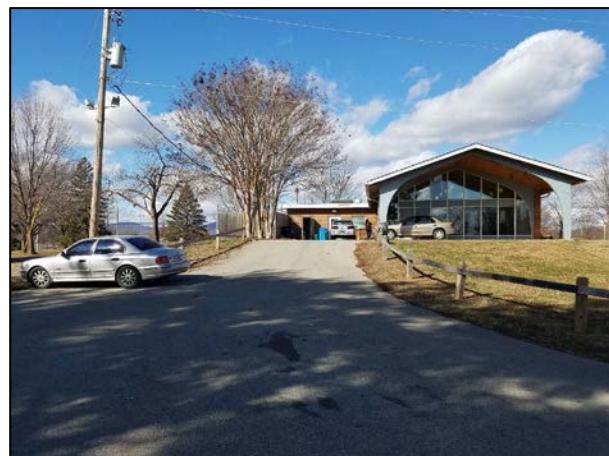
Paved Parking Area

The drive consists of asphalt in fair structural condition from the street to the building. Asphalt edge conditions are good but vulnerable to grass intrusion without the presence of concrete curbing. The existing wooden fence rail system is in good condition, but is not substantial enough to provide vehicular resistance if that was its intent. Vertical posts show far less sign of deterioration than the horizontal members.

**Recommendation:** Provide asphalt sealing and line restriping as well as asphalt edge maintenance including weed eating/edging followed by herbicide application to prevent grass intrusion into the asphalt and future raveling and deterioration within the next 2-5 years.

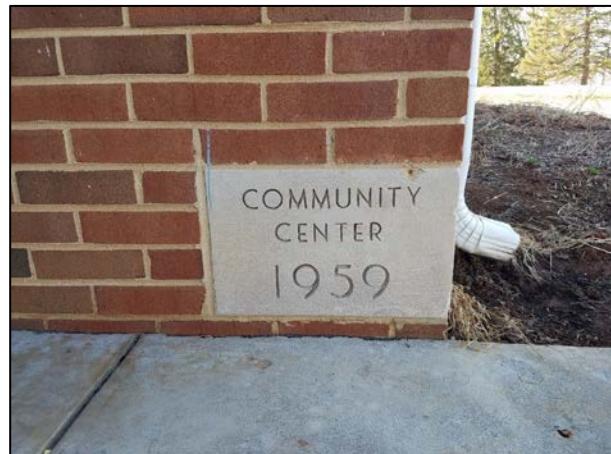
Typical Downspout Conditions

All roof drainage is “disconnected” or not connected to storm sewer. Each downspout is allowed to discharge directly to grade. As long as ponding is not created against the building foundations and adequate slope away from the building is provided, this is the preferred condition for treating roof drainage. Site Drainage does not appear to require any maintenance.

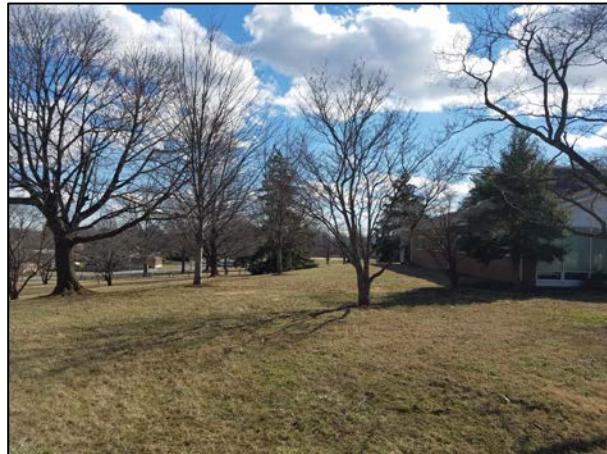
Tree Variety

The site has a variety of landscape trees and very few shrubs and beds. This approach is best suited for low maintenance operations. The species and conditions of the trees are very good and distances between them limit the needs for pruning. Some will require minor maintenance over time.

**Recommendation:** Within the next appropriate season by species, inspect maples for black knot and remove by pruning, trim the crepe myrtles along top of the driveway, trim evergreen lower branches to 18" above the ground, and thin the large maple adjacent to the driveway entrance for hanging and dead limbs.

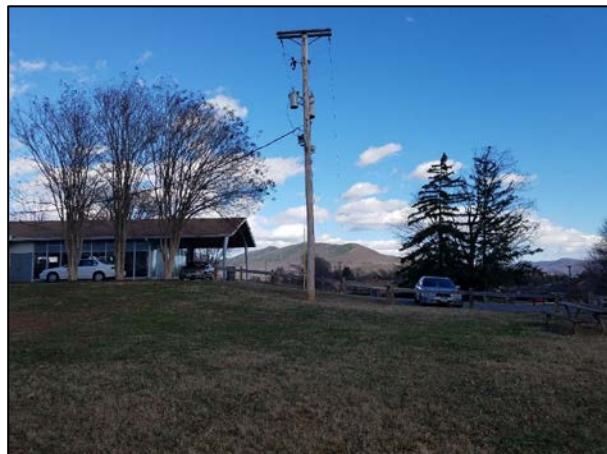
Crepe Myrtles to be pruned

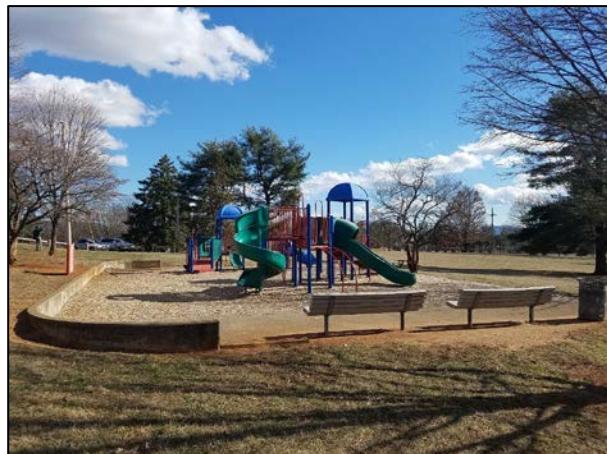
Playground

The existing playground to the south of the center is well kept and requires no immediate maintenance other than routine inspection; however, the age of the equipment and proximity to future building expansion will place a strong desire to replace the playground in a new location. The retaining wall above the playground is in sound condition and below the elevations that require a handrail. Benches and trash receptacles are in good condition.

**Recommendation:** Perform routine or insurance required inspections. Plan for the playground to be relocated to a new location and modern equipment installed.

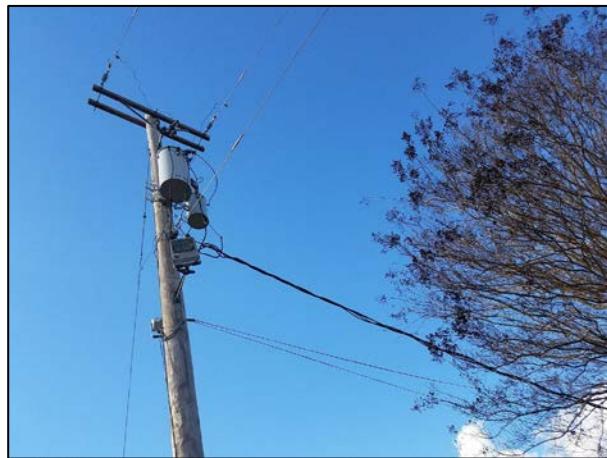
Dual Site Lights (APCO)

Besides street lighting, the property has a pair of pole mounted exterior light fixtures mounted to the power service pole (AEP #230-1199) south of the building. The fixtures are modern and in good condition. They do not appear metered and are possibly rented from APCO.

**Recommendation:** Perform routine inspections for function.

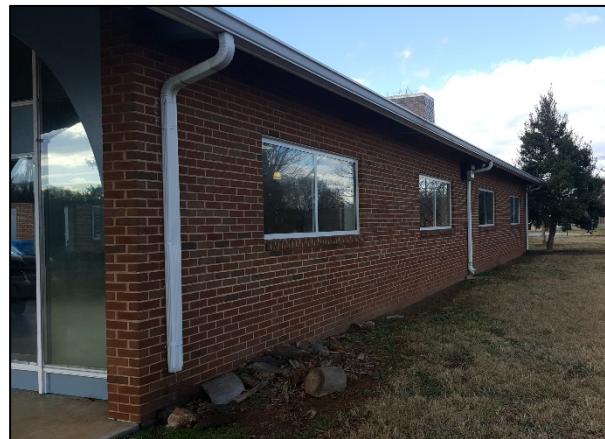
Typical Exterior Masonry

The support area of Preston Park Recreation Center is a multi-wythe masonry building with concrete block masonry interior and brick veneer. It does not appear that the building is cavity wall construction. The masonry is in good condition.

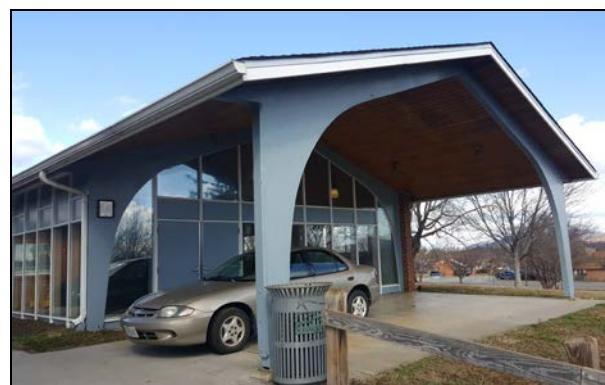
Glulam Porch and Windows

The community room has single-pane glass supported by wood framing floor-to-roof on the south and west faces. The windows in brick openings are prefinished aluminum frames.

**Recommendation:** Replace single pane windows with insulated glass units within the next 10 years.

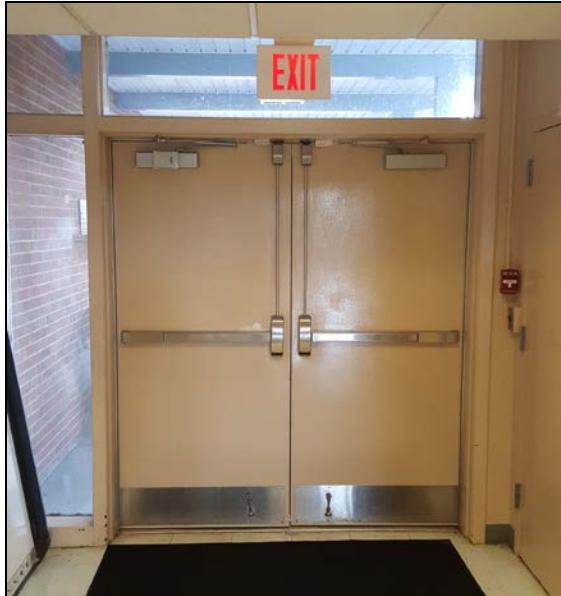
Exterior Door with Panic Hardware

The exterior doors are hollow metal in metal frames. The doors are in good condition. The hardware has been replaced with ADA compliant lever style sets. The egress devices are the newer style “push rail” type which cannot be chained.

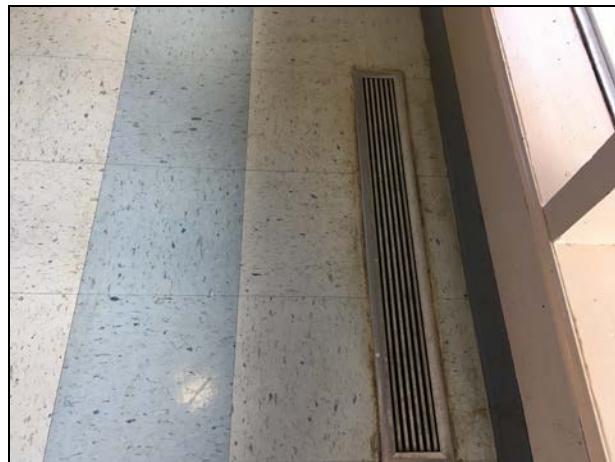
VCT at Community Room

Generally, floors in the center are vinyl composite tile (VCT). The VCT was installed as part of the 2005 renovation. The floors in the community room are showing damage from wear and moisture.

**Recommendations:** VCT floors should be stripped and cleaned at regular intervals as recommended by the flooring manufacturer. Areas of VCT with moisture damage should be replaced.

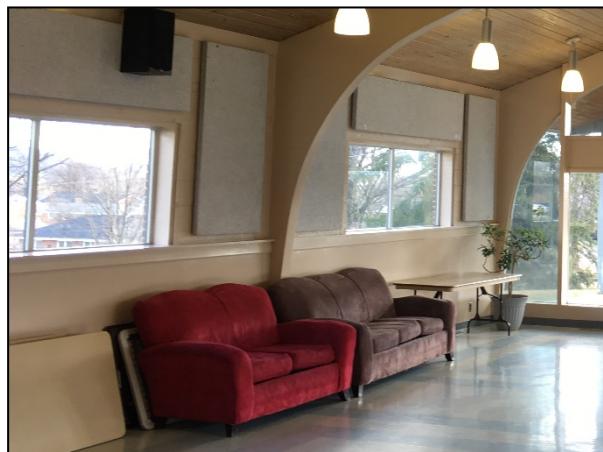
Interior Walls with Tectum Panels

Tectum acoustical wall panels were added to the multi-purpose room in 2005. The panels are in generally good condition.

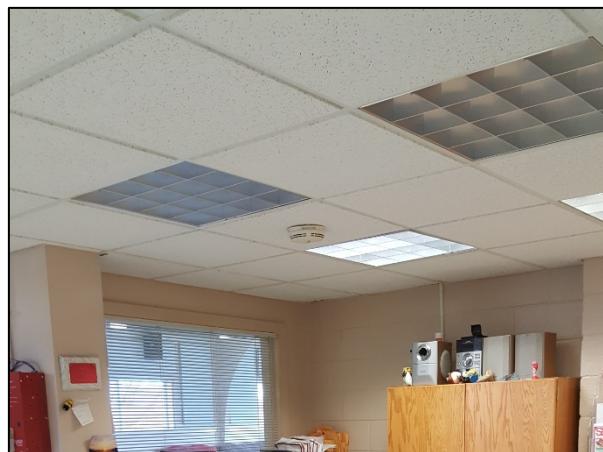
Typical ACT Ceiling

Other areas of the building have 2x2 acoustical tile ceilings (ACT) that were installed in 2005. The ceilings are generally in good condition but are showing signs of age.

**Recommendation:** ACT ceiling tiles should be replaced when they become dirty or damaged.

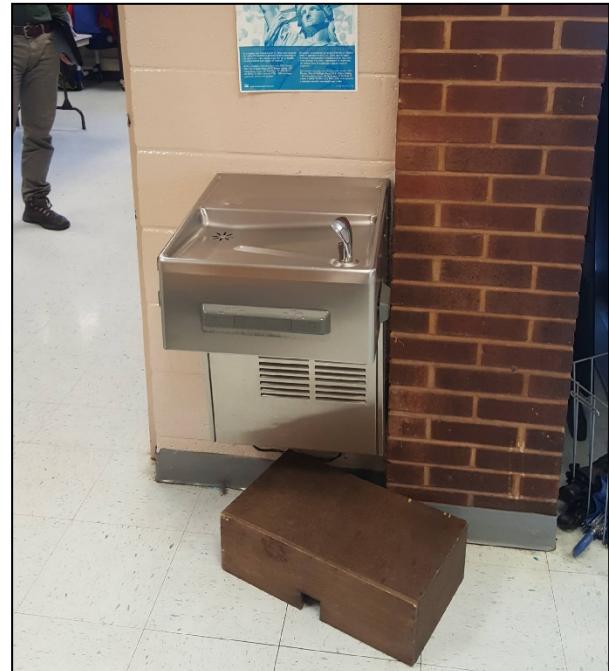
Water Cooler

A single level accessible water cooler is located at the entry. Two levels are required by ADA and plumbing code.

**Recommendation:** Install an additional water cooler at the higher level or provide a new dual level water cooler.

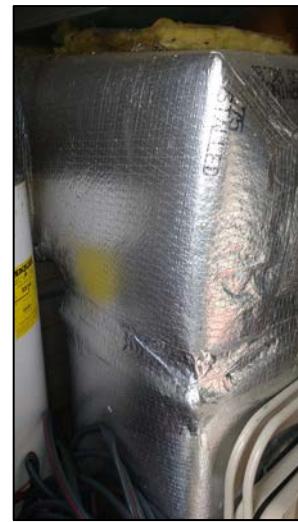
Duct Plenum to Underslab

Existing equipment is in fair condition and have an expected 5 to 10 years useful life if well-maintained. Under-slab ducting may be past its expected useful life; at minimum a thorough cleaning is recommended. Also, existing equipment yard location needs to be considered in the placement of any adjacent, new additions.

Air distribution is via under-slab ductwork through this space, arranged in a perimeter configuration. The below-grade ductwork's age is unknown, but it is likely original and has likely exceeded its typical expected lifespan.

Additionally, under-slab ducting poses a risk of moisture intrusion in the form of water leaks and condensation forming on the inside of ducting. Ducting and insulation between the outdoor equipment and into the mechanical room has recently been replaced, and is in excellent condition. A large, central return is located behind the main desk.

**Recommendation:** Clean existing under-slab ductwork. Plan to replace HVAC system within the next five to ten years.

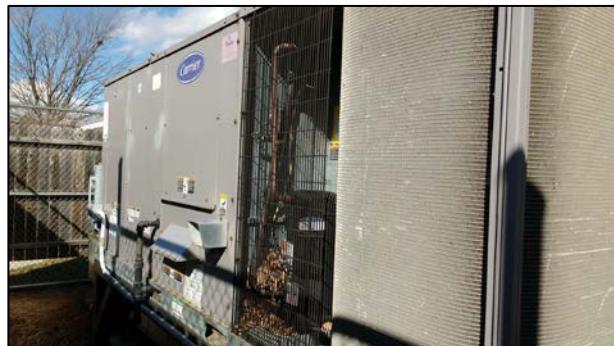
Packaged Air Handling Unit

A packaged Carrier air handling units provide heating, cooling, and ventilation. The unit provides two-stage DX cooling (approximately 16 tons capacity), gas-fired heating, economizer, and powered exhaust. The unit appears to be in good condition and likely installed within the past five years. Electrical requirement for this unit is 3-phase, 208/230V. Note that the outside air intake does not have adequate clearance from the supply duct, possibly leading to excessive noise or reduced fresh air ventilation.

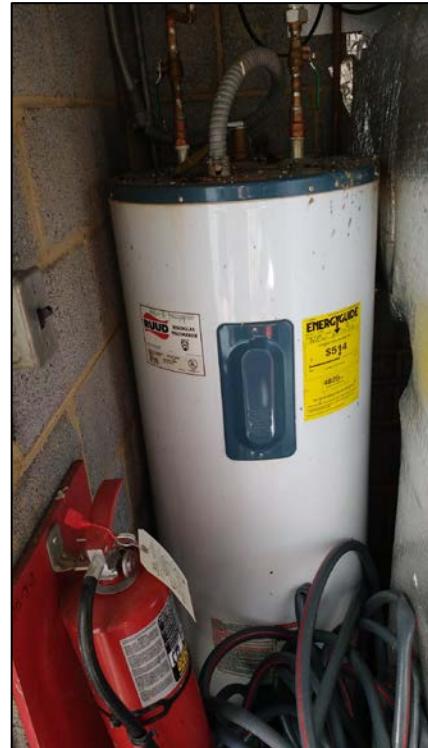
Domestic Water Heater

Domestic hot water is produced using a 50-gallon, 4.5kW input electric water heater that appears to be in fair condition. No expansion tanks is evident on water heater. No floor drain or drip pan was observed however the floor drain may have been covered and not visible.

No floor drains were observed. A floor drain is required at the water heater.

**Recommendation:** Verify floor drain or drip pan is present at water heater.

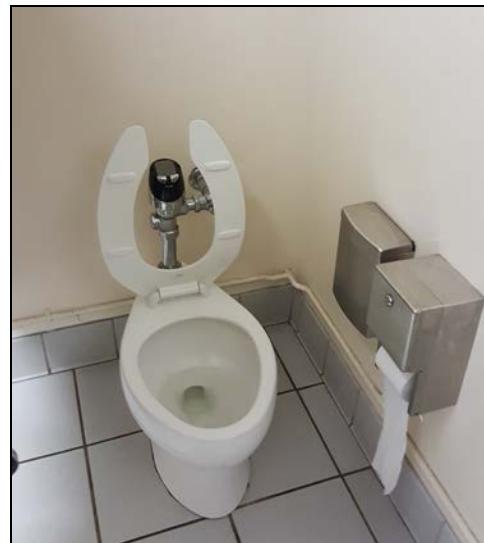
Typical Restroom

The men's room contains one water closet, one urinal and one lavatory. The women's room contains two water closets and one lavatory. The accessible restroom contains one toilet and one lavatory.

The fixtures appear to be in good condition and have been updated. The flush valves have recently been upgraded to hands-free sensor flush. Lavatories are wall-mounted. Flush valves are standard and do not appear to be low flow type. The lavatories and toilets were functional at the time of writing. No changes recommended at this time.

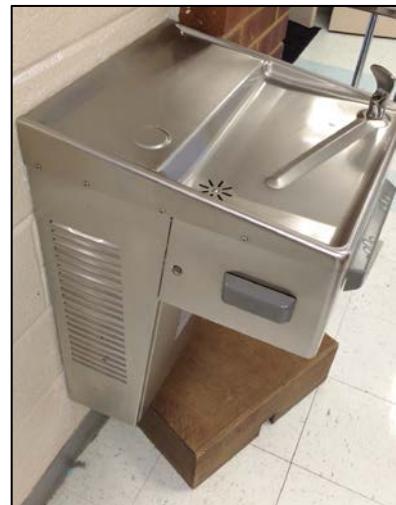
Electric Water Cooler

A water cooler was observed in the common area in good condition, and is estimated to be 5 years or less in age.

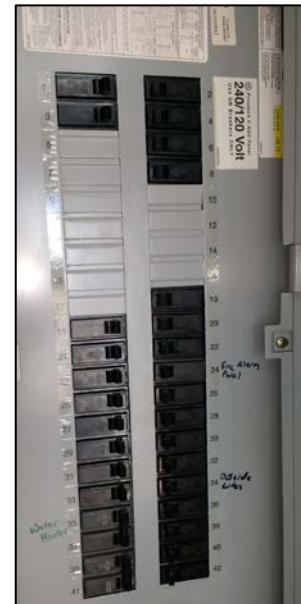
Distribution Panel

The service routes through a 200A GE 240/120V distribution panel, which has been replaced and is in good condition. Electrical distribution continues under-slab.
