# ROANOKE PARKS AND RECREATION PRESTON PARK RECREATION CENTER FEASIBILITY STUDY

AUGUST 4, 2017  
PROJECT NO. 16100

# Preston Recreation Center Feasibility Study

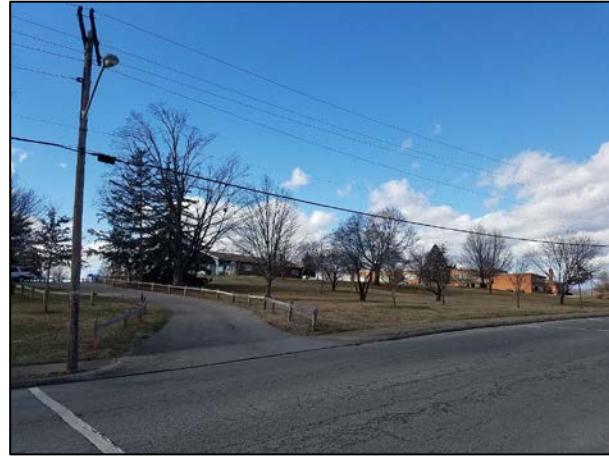
Winsloe Dr. Entrance to Parking

The drive consists of asphalt in fair structural condition from the street to the building. Asphalt edge conditions are good but vulnerable to grass intrusion without the presence of concrete curbing. The existing wooden fence rail system is in good condition, but is not substantial enough to provide vehicular resistance if that was its intent. Vertical posts show far less sign of deterioration than the horizontal members.

The parking lot provides (18) standard auto parking spaces and (1) 10'x25' delivery space. Six of the auto spaces are on asphalt and the remaining 12 are grass parking. A single Handicapped space is required by ADA and two are provided along Preston Avenue at the front door entry sidewalk. The building porch is currently used for parking although use of these spaces do not appear to be intended.

**Recommendation:** Provide asphalt sealing and line restriping as well as asphalt edge maintenance including weed eating/edging followed by herbicide application to prevent grass intrusion into the asphalt and future raveling and deterioration within the next 2-5 years.

Replace the horizontal parking lot fence members within the next 2-5 years with more substantial 3"x6" lumber.

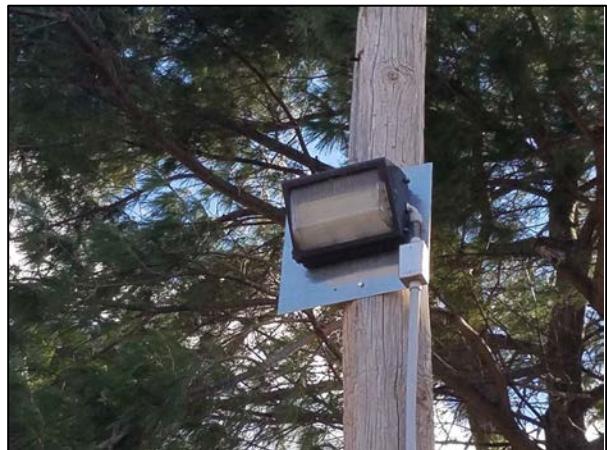
Wall Mount Fixture on Pole

Besides street lighting, the property has a pair of pole mounted exterior light fixtures mounted to the power service pole (AEP #230-1199) south of the building. The fixtures are modern and in good condition. They do not appear metered and are possibly rented from APCO.

**Recommendation:** Perform routine inspections for function.

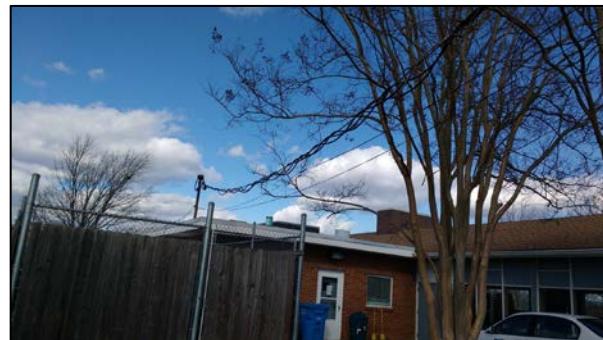
Electrical Service Entrance

Much of the electrical wiring is below slab and not visible; as such, the electrical wiring throughout the building is likely typical of that expected based upon the date of installation. Disconnect switches and general wiring throughout the building are consistent with current codes, and appear to be largely in good condition.

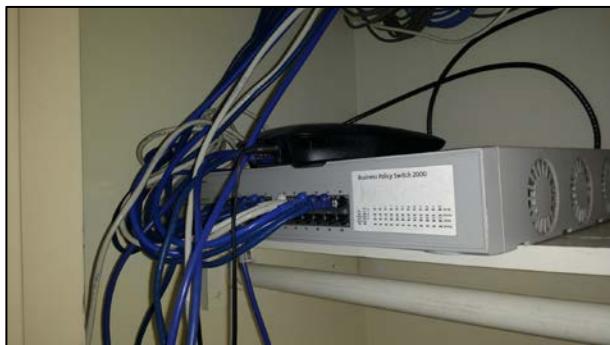
Network Switch

The facility has copper telephone service available, and a significant number of copper telephone extensions are installed throughout the building. As in most similar facilities, it is expected that future additions in the voice communication arena will move in the VOIP (Voice Over IP) direction, and that existing copper systems will not be expanded.

**Recommendation:** Consider exploring available sources for VOIP to allow for modernization and improvements to the data/communications system.
